This MotoCAP safety rating applies to:

Brand: Rev'it
Model: Factor 3
Type: Pants - Textile
Date purchased: 29 November 2018
Sizes tested: L
Gender: M & F
Style: All Purpose
Test code: P18T09

Test Results Summary:

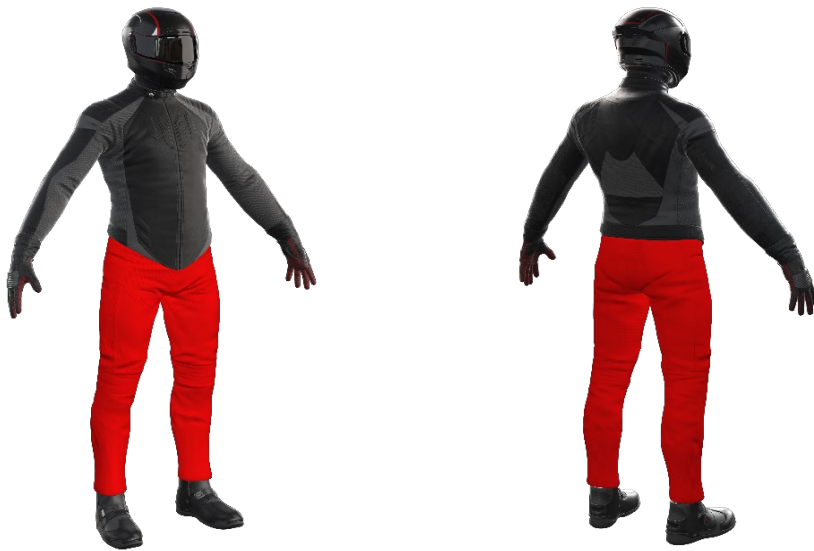
| Zone | Coverage (%) | Abrasion time for each test (seconds) | | | | | | Average (seconds) | |
|--|---|---|---|---|---|---|---|---|---|
| Material A | 20% | 0.77 | 0.63 | 0.86 | 0.98 | 0.00 | 0.00 | 0.81 | P |
| Material B | 80% | 0.36 | 0.28 | 0.30 | 0.36 | 0.35 | 0.68 | 0.39 | P |

The diagram below is a visual indication of the likely abrasion performance of the materials in each zone calculated from the data in the table above. The colour coding is based on the worst performing material in each zone.

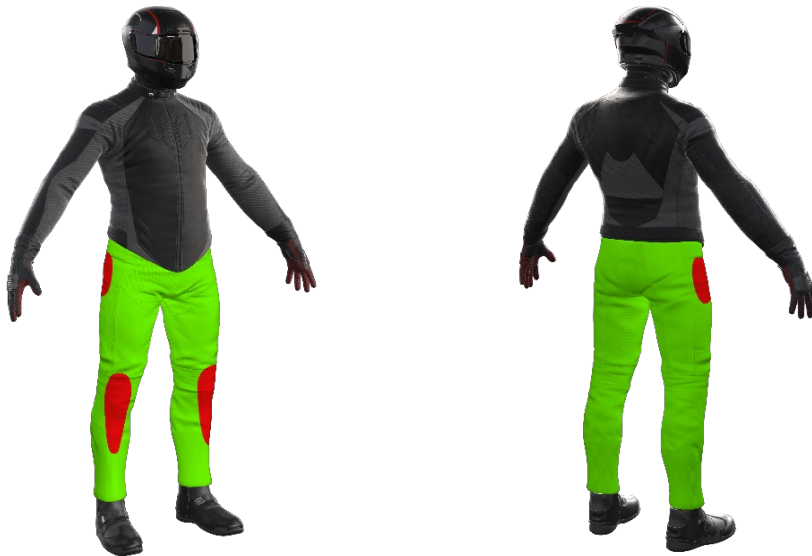
| Area | 1 | 2 | 3 | 4 | 5 | Average | |
|---|---|---|---|---|---|---|---|
| Zones 1 & 2 | 89 | 335 | 696 | 142 | 429 | 338 | P |

The diagram below illustrates the burst strength results in terms of the likely performance of the garment in an impact and is a pictorial representation of the data from the table above.

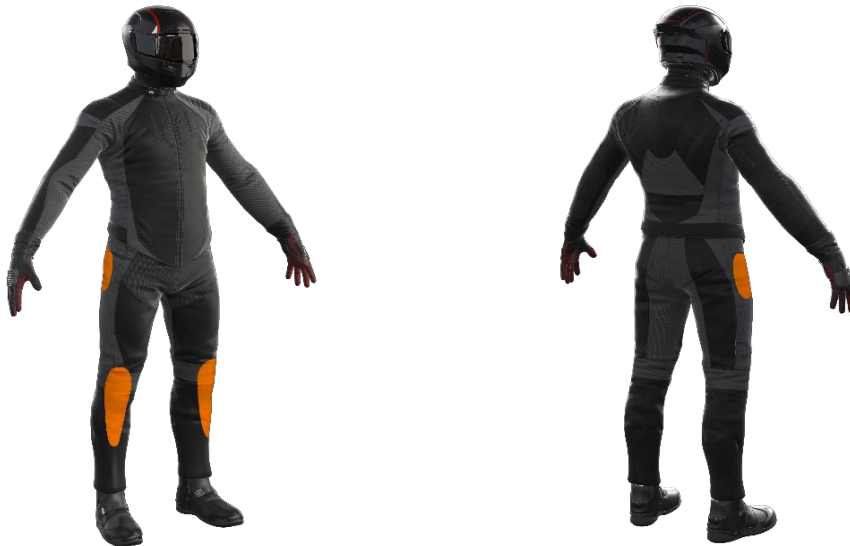
| Impact protector type | Knee | | | Hip | | |
|---|---|---|---|---|---|---|
| Average force (kN) | 24.4 | M | | 28.7 | M | |
| Maximum force (kN) | 31.6 | M | | 29.4 | M | |

The diagram below is a visual indication of the likely performance of each impact protector calculated from the data in the table above. The colour coding is based on the worst performing score for average or maximum force for each impact zone.
