This MotoCAP safety rating applies to:

Brand: DriRider
Model: Nordic 3 Airflow
Type: Jacket - Textile
Date purchased: 11 February 2019
Sizes tested: L and XL
Gender: M
Style: Tourer
Test code: J19T07

Test Results Summary:

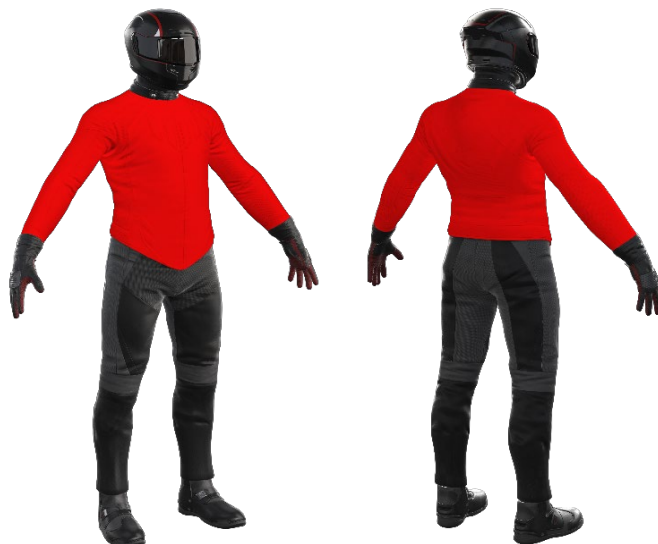
Zone	Coverage (%)	Abrasion time for each test (seconds)						Average (seconds)	
		1	2	3	4	5	6		
Zone 1 and 2 areas (High abrasion risk)									
Material A	90%	3.11	2.75	2.23	2.43	3.43	3.49	2.91	M
Material B	10%	0.56	0.30	0.14	0.18	0.53	0.70	0.40	P
Zone 3 area (Medium abrasion risk)									
Material C	80%	0.36	0.37	0.24	0.16	0.21	0.20	0.26	P
Material B	20%	0.56	0.30	0.14	0.18	0.53	0.70	0.40	P
Zone 4 area (Low abrasion risk)									
Material C	70%	0.36	0.37	0.24	0.16	0.21	0.20	0.26	P
Material B	30%	0.56	0.30	0.14	0.18	0.53	0.70	0.40	M

The diagram below is a visual indication of the likely abrasion performance of the materials in each zone calculated from the data in the table above. The colour coding is based on the worst performing material in each zone.

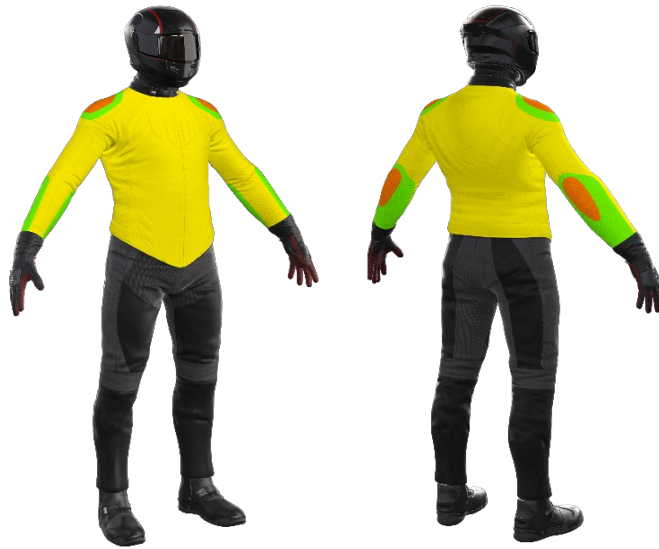
Area	1	2	3	4	5	Average	
Zones 1 & 2	812	604	604	759	588	674	M
Zone EZ	1260	1730	1575	964	1386	1383	G
Zones 3 & 4	890	693	1254	713	723	855	A

The diagram below illustrates the burst strength results in terms of the likely performance of the garment in an impact and is a pictorial representation of the data from the table above.

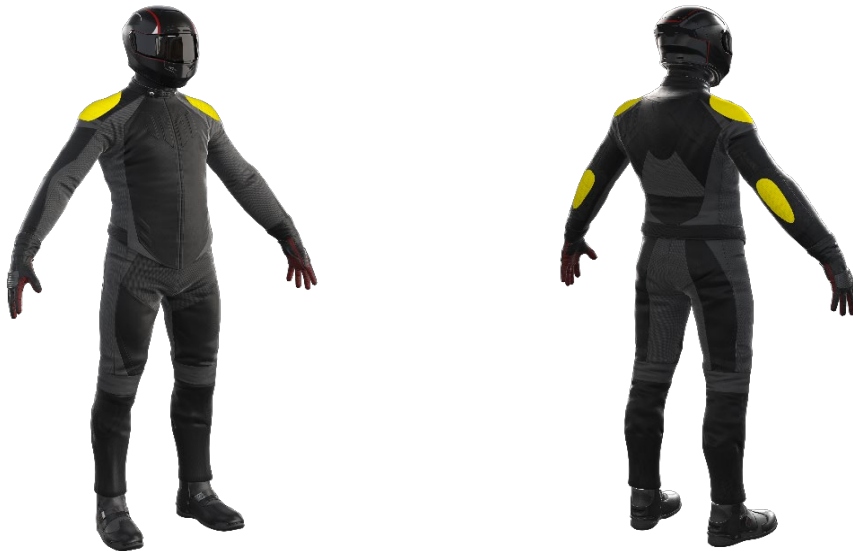
Impact protector type	Elbow		Shoulder	
Average force (kN)	19.7	A	20.3	A
Maximum force (kN)	20.4	A	20.9	A
Coverage of zone 1 area	95%		95%	
Coverage of zone after displacement	80%		95%

The diagram below is a visual indication of the likely performance of each impact protector calculated from the data in the table above. The colour coding is based on the worst performing score for average or maximum force for each impact zone.
