**This MotoCAP safety rating applies to:**

**Brand:** Rjays  
**Model:** Voyager V Ladies  
**Type:** Pants - Textile  
**Date purchased:** 26 August 2019  
**Sizes tested:** XL and 2XL  
**Gender:** F  
**Style:** Tourer  
**Test code:** P19T07

**Test Results Summary:**

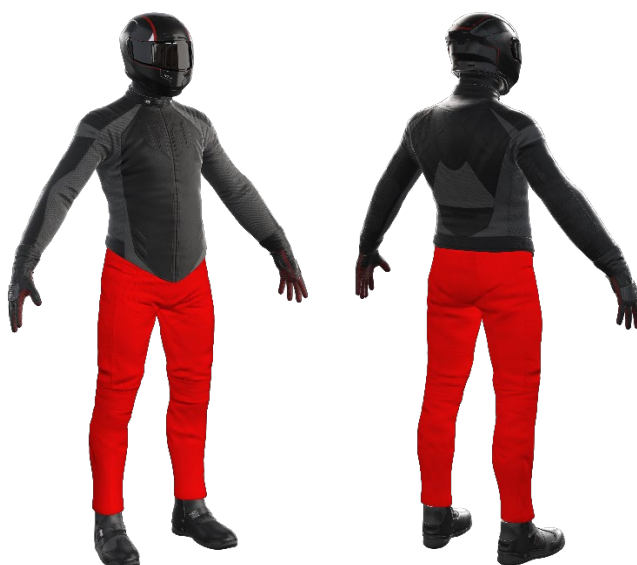
Zone	Coverage (%)	Abrasion time for each test (seconds)						Average (seconds)	
		1	2	3	4	5	6		
<b>Zone 1 and 2 areas (High abrasion risk)</b>									
Material A	100%	0.46	0.24	0.30	0.43	0.23	0.31	0.33	P
<b>Zone 3 area (Medium abrasion risk)</b>									
Material A	100%	0.46	0.24	0.30	0.43	0.23	0.31	0.33	P
<b>Zone 4 area (Low abrasion risk)</b>									
Material A	100%	0.46	0.24	0.30	0.43	0.23	0.31	0.33	P

The diagram below is a visual indication of the likely abrasion performance of the materials in each zone calculated from the data in the table above. The colour coding is based on the worst performing material in each zone.

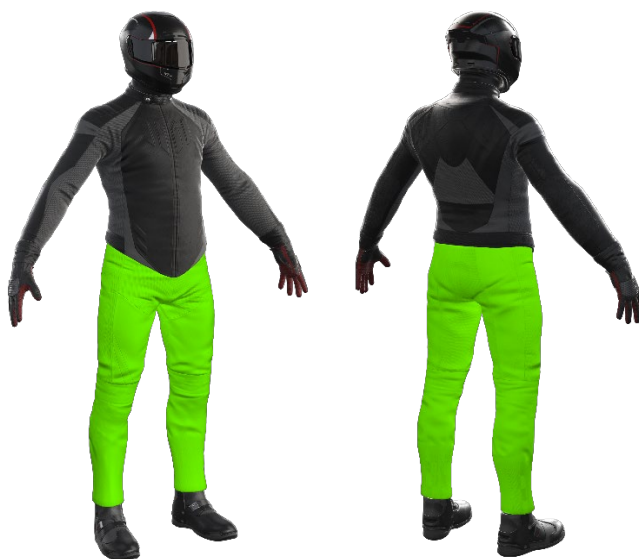
Area	1	2	3	4	5	Average	
Zones 1 & 2	764	1421	1385	834	807	1042	G
Zone EZ	1237	642	1185	1132	973	1033	G
Zones 3 & 4	996	1304	1210	1360	885	1151	G

The diagram below illustrates the burst strength results in terms of the likely performance of the garment in an impact and is a pictorial representation of the data from the table above.

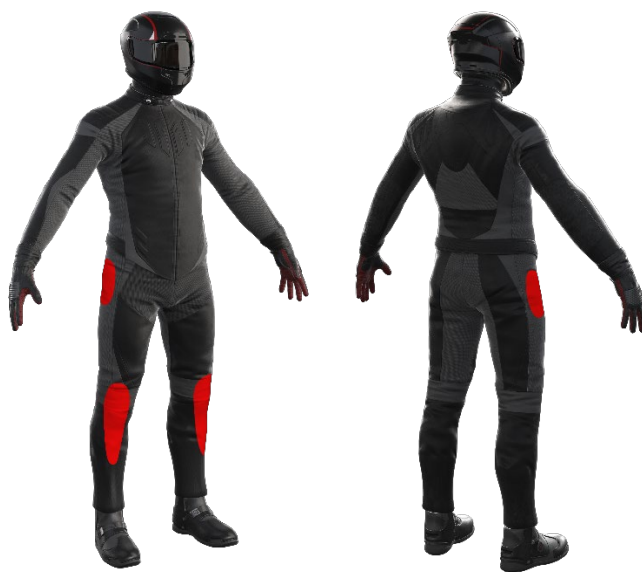
Impact protector type	Knee			None		
Average force (kN)	28.2	M			P	
Maximum force (kN)	39.8	P			P	
Coverage of zone 1 area	80%			0%		
Coverage of zone after displacement	75%			0%		
Individual test results						
Impact force (kN)	Knee			None	No impact protector present	
Strike location	A	B	C	A	B	C
Impact Protector 1	18.0	24.2	30.2			
Impact Protector 2	19.9	23.4	39.8			
Impact Protector 3	21.3	37.4	39.3

The diagram below is a visual indication of the likely performance of each impact protector calculated from the data in the table above. The colour coding is based on the worst performing score for average or maximum force for each impact zone.
