This MotoCAP safety rating applies to:

Brand	Harley Davidson
Model	Eagle Logo Distressed
Type	Jacket - Leather
Date purchased	13 January 2021
Sizes tested	L
Test garment gender	Female
Style	Cruiser
RRP	\$686.94

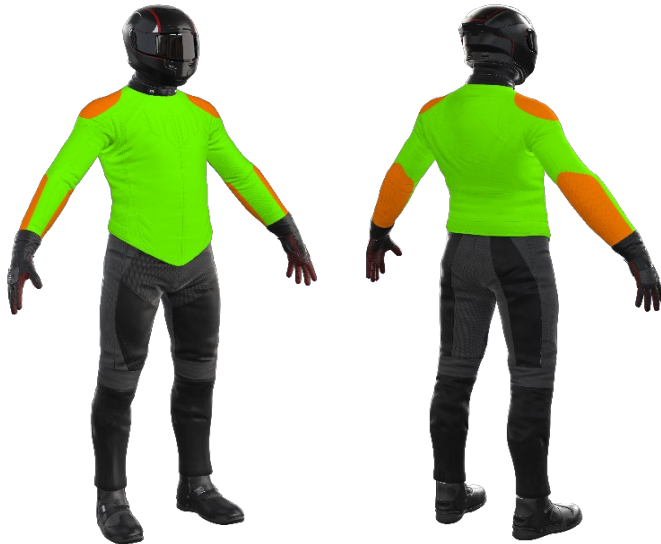
Abrasion Resistance Performance

Abrasion rating	4/10
Abrasion score	2.82

Zones 1 & 2	Coverage (%)	Sample 1	Sample 2	Sample 3	Sample 4	Sample 5	Sample 6	Average	
Material A	100%	2.48	2.63	2.88	2.98	2.99	2.94	2.82	M
Zone 3	Coverage (%)	Sample 1	Sample 2	Sample 3	Sample 4	Sample 5	Sample 6	Average	
Material A	100%	2.48	2.63	2.88	2.98	2.99	2.94	2.82	G
Zone 4	Coverage (%)	Sample 1	Sample 2	Sample 3	Sample 4	Sample 5	Sample 6	Average	
Material A	100%	2.48	2.63	2.88	2.98	2.99	2.94	2.82	G

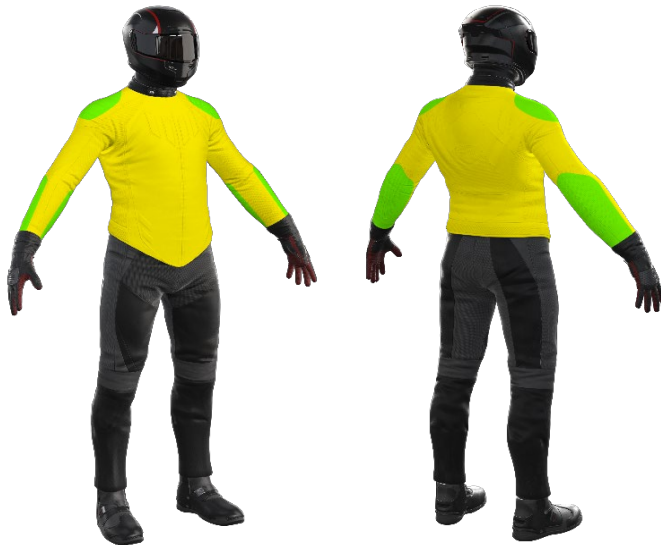
Burst Strength Performance

Burst rating	10/10
Burst score	1183

Area	Sample 1	Sample 2	Sample 3	Sample 4	Sample 5	Sample 6	Average	
Zones 1 & 2	1313	1574	993	1266	1001	1447	1266	G
Zones 3 & 4	405	672	596	1479	1259	698	851	A

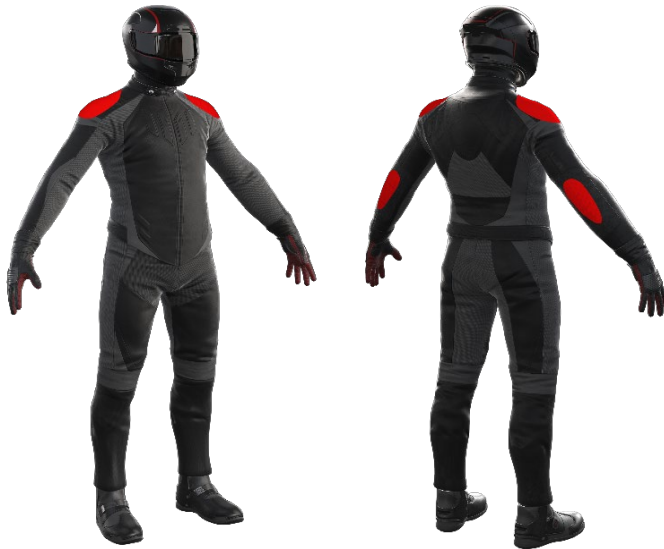
Impact Protection Performance

This jacket was not tested for impact protection as impact protectors were not provided with the garment. The diagram below is a visual indication of the likely performance of each impact protector calculated from the data in the table below. The colour coding is based on the worst performing score for average or maximum force for each impact zone. Areas shaded black are not considered for impact protection ratings.

Impact rating 0/10
Impact score 0.0

There are no pockets provided at the shoulders, elbows or back for fitting aftermarket impact protectors. Adding elbow and shoulder impact protector pockets and impact protectors would improve the protection levels of this garment. There are no vents to allow airflow movement through the garment.
