**This MotoCAP safety rating applies to:**

**Brand:** Triumph  
**Model:** Exploration  
**Type:** Jacket - Textile  
**Date purchased:** 11 February 2019  
**Sizes tested:** XL  
**Gender:** M  
**Style:** Tourer  
**Test code:** J19T12

**Test Results Summary:**

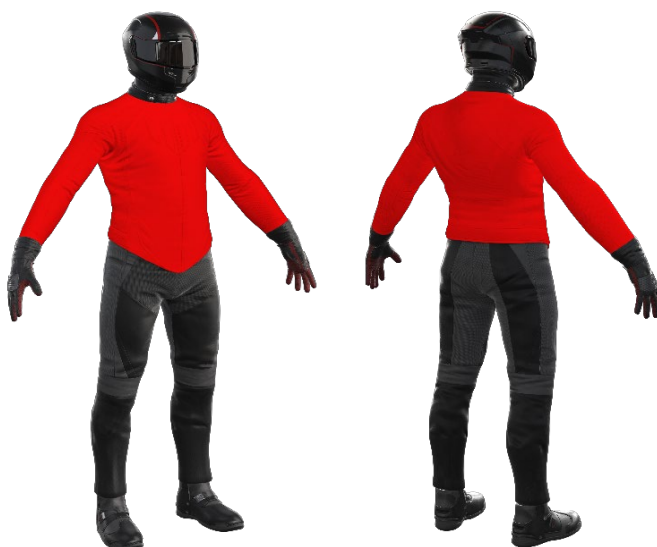
Zone	Coverage	Abrasion time for each test (seconds)						Average	
	(%)	1	2	3	4	5	6	(seconds)	
Zone 1 and 2 areas (High abrasion risk)									
Material A	90%	0.46	0.29	0.18	0.27	0.14	0.25	0.26	P
Material B	10%	Shell fabric was too small for test sample collection							
Zone 3 area (Medium abrasion risk)									
Material A	100%	0.46	0.29	0.18	0.27	0.14	0.25	0.26	P
Zone 4 area (Low abrasion risk)									
Material A	100%	0.46	0.29	0.18	0.27	0.14	0.25	0.26	P

The diagram below is a visual indication of the likely abrasion performance of the materials in each zone calculated from the data in the table above. The colour coding is based on the worst performing material in each zone.

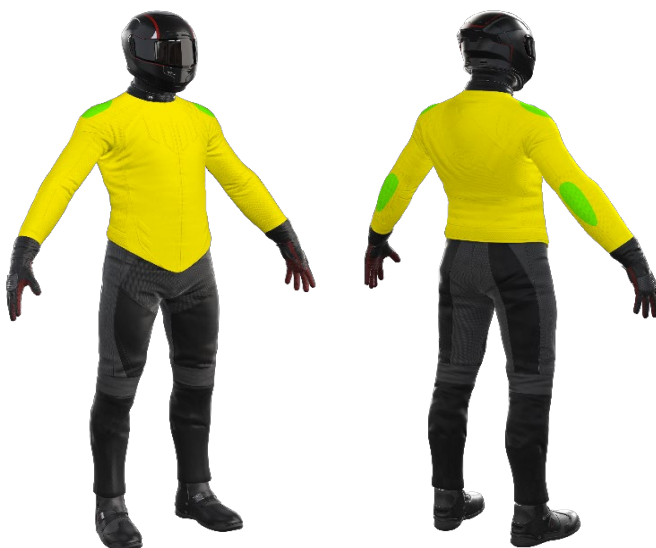
Area	1	2	3	4	5	Average	
Zones 1 & 2	1557	1621	1354	1366	1284	1436	G
Zone EZ	1006	446	890	1262	857	892	A
Zones 3 & 4	1065	1032	563	901	1003	913	A

The diagram below illustrates the burst strength results in terms of the likely performance of the garment in an impact and is a pictorial representation of the data from the table above.

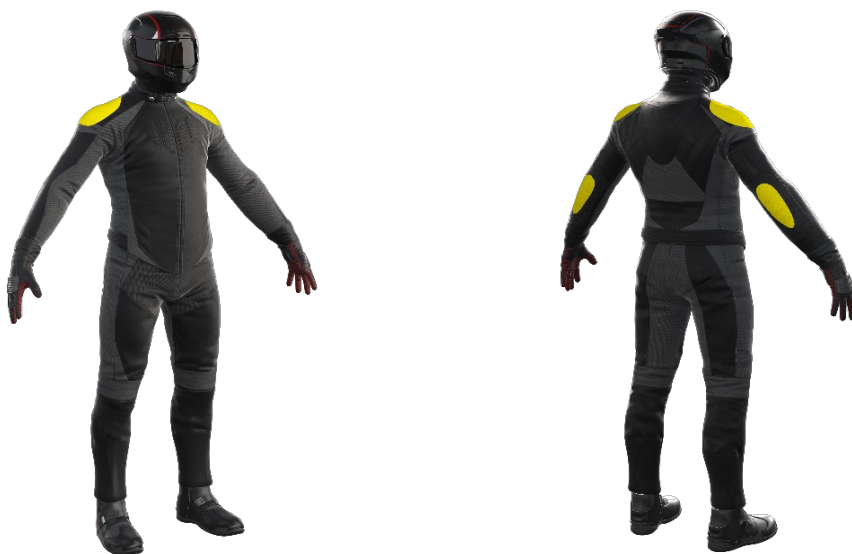
Impact protector type	Elbow		Shoulder	
Average force (kN)	17.9	A	18.2	A
Maximum force (kN)	19.2	A	19.1	A
Coverage of zone 1 area	130%		110%	
Coverage of zone after displacement	100%		70%

The diagram below is a visual indication of the likely performance of each impact protector calculated from the data in the table above. The colour coding is based on the worst performing score for average or maximum force for each impact zone.
