This MotoCAP safety rating applies to:

Brand	Merlin
Model	Harriet Ladies
Туре	Jacket - Textile
Date purchased	22 November 2023
Sizes tested	L and XL
Test garment gender	Female
Style	All Purpose
RRP	\$549.95

Assessment Details.	
Brand	Merlin
Model	Harriet Ladies
Туре	Jacket - Textile
Date purchased	22 November 2023
Tested by	AMCAF, Deakin University
Report approved by	MotoCAP Chief Scientist
Garment test reference	J24T12
Rating first published	January 2024
Rating updated	29 January 2024

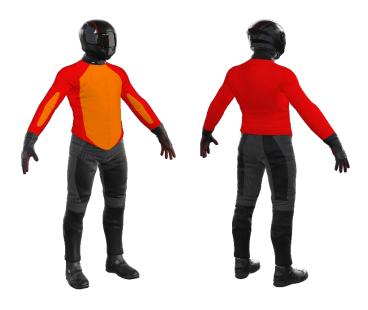
The jacket was tested for abrasion resistance in accordance with MotoCAP test protocols. The diagram below is a visual indication of the likely abrasion performance of the materials in each zone calculated from the data in the table below. The colour coding is based on the worst performing material in each zone.

Abrasion Resistar	nce Performance
Abrasion rating	1/10

-/ -0
Abrasion score	1.09

Zone 1 & 2	Coverage (%)	Sample 1	Sample 2	Sample 3	Sample 4	Sample 5	Sample 6	Average
Material A	65%	10.00	10.00	10.00	10.00	10.00	N/A	10.00 G
Material B	35%	0.40	0.59	0.64	1.05	1.02	0.45	0.69 P
Zone 3	Coverage (%)	Sample 1	Sample 2	Sample 3	Sample 4	Sample 5	Sample 6	Average
Material B	100%	0.40	0.59	0.64	1.05	1.02	0.45	0.69 P
Zone 4	Coverage (%)	Sample 1	Sample 2	Sample 3	Sample 4	Sample 5	Sample 6	Average
Material B	100%	0.40	0.59	0.64	1.05	1.02	0.45	0.69 M

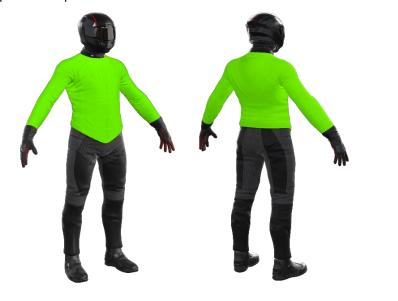
The jacket was tested for burst strength in accordance with MotoCAP test protocols. The diagram below illustrates the burst strength results in terms of the likely performance of the garment in an impact and is a pictorial representation of the data from the table below.

Burst Strength	Performance
Burst rating	10/10
Burst score	1372

Area	Sample 1	Sample 2	Sample 3	Sample 4	Sample 5	Sample 6	Average	
Zones 1 & 2	1786	1851	1901	1202	923	793	1409	G
Zones 3 & 4	1790	643	1247	1423	1163	1087	1226	G

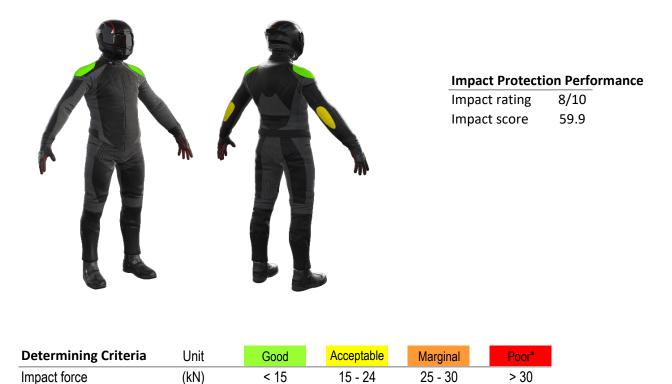
The jacket was tested for impact protection and coverage in accordance with MotoCAP test protocols. The diagram below is a visual indication of the likely performance of each impact protector calculated from the data in the table below. The colour coding is based on the worst performing score for average or maximum force for each impact zone. Areas shaded black are not considered for impact protection ratings.

Impact protector type	Elbow		Shoulder
Average force (kN)	13.2	G	10.9 <mark>G</mark>
Maximum force (kN)	17.1	A	12.6 G
Coverage of Zone 1 area	115%		105%
Coverage of Zone after displacement	90%		100%

Impact protector type	Elbow	Shoulder				
Strike location	Centre	Mid	Edge	Centre	Mid	Edge
Impact Protector 1	11.4	12.5	17.1	9.8	11.2	12.6
Impact Protector 2	12.8	12.4	14.8	10.0	10.7	11.7
Impact Protector 3	11.4	12.5	13.8	9.6	11.1	11.6
