## This MotoCAP safety rating applies to:

| Model | Flex Layering Café Racer |
| Type | Jacket - Leather |

| Garment test reference | J23L22 |

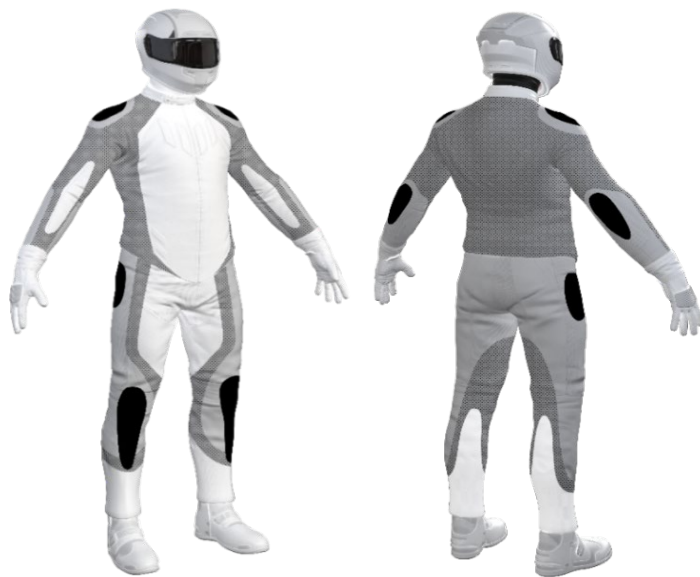
Pockets are provided at the shoulders, elbows and back for fitting aftermarket impact protectors. Adding elbow and shoulder impact protectors would improve the protection levels of this garment. There are no vents to allow airflow movement through the garment. There is the potential for burns from heat transferred through the metal snap fasteners on the front of the jacket during a slide.
