This MotoCAP safety rating applies to:

Brand	RST
Model	Ripley CE Ladies
Type	Jacket - Leather
Date purchased	29 June 2023
Sizes tested	14
Test garment gender	Female
Style	All Purpose
RRP	$499.99

**RST Ripley CE Ladies
Leather Jacket**

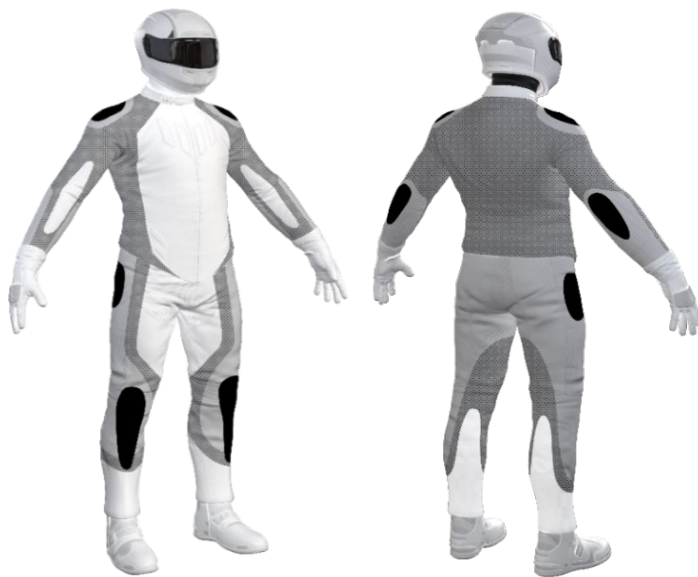
Test Results Summary	Rating	Score
MotoCAP Protection Rating	★★★★	61.3
Abrasion	10/10	7.45
Burst	10/10	1477
Impact	4/10	31.1
MotoCAP Breathability Rating	★★	0.308
Moisture Vapour Resistance	-	53.9
Thermal Resistance	-	0.277
Water resistance	N/A	N/A

This garment is fitted with impact protectors for the elbows and shoulders. A pocket is provided for an aftermarket back protector. Replacing the elbow armour with higher performing impact protectors would improve the protection levels of this garment. There are no vents to allow airflow movement through the garment.
