This MotoCAP safety rating applies to:

Brand	Triumph
Model	Cranbourne
Type	Jacket - Textile
Date purchased	8 April 2025
Sizes tested	L and XL
Test garment gender	Male
Style	All Purpose
RRP	$610.82

Assessment Details.

Brand	Triumph
Model	Cranbourne
Type	Jacket - Textile
Date purchased	8 April 2025
Tested by	AMCAF, Deakin University
Report approved by	MotoCAP Chief Scientist
Garment test reference	J25T28
Rating first published	June 2025
Rating updated	25 June 2025

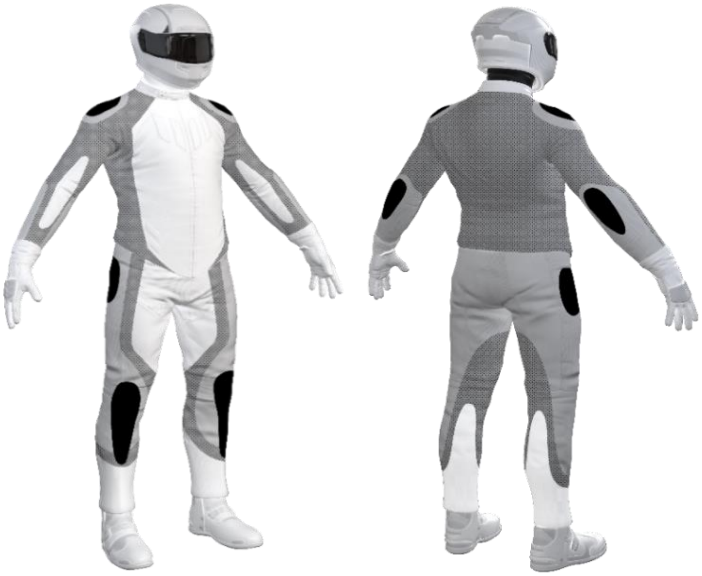
Jacket and Pants - Crash Impact Risk Zones

Zone 1	Zone 2	Zone 3	Zone 4
High risk of abrasion High risk of impact	High risk of abrasion	Medium risk of abrasion	Low risk of abrasion
